Manhole Inspection Summary

Manhole # S21K__026MH

Location Address: **1844 wilhelm st**

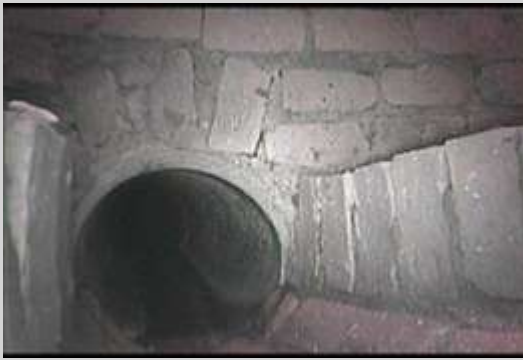
12 O'Clock Outflow

8 in. Circular Gravity Sewer
Pipe Out @ 12 O'Clock

Pipe Height: **7.2** (in.) Rod and Bar (Angled)
Pipe Material: **Clay** ☐ Pipe Lined
Invert Depth: **7.97** (ft.) Flow Characteristics: **Slow**
Deposits: ☒ None ☐ **Mud** ☐ Sludge ☐ Debris ☐ Grease
Silt Depth: **0** (in.) Deposits Extent:
Infiltration: **None** Pipe Seal Cond: **Sound**

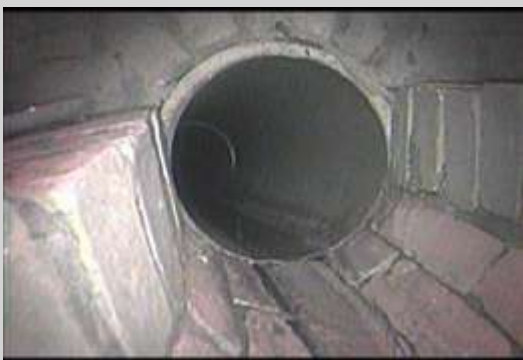
3 O'Clock Inflow

8 in. Circular Gravity Sewer
Pipe In @ 3 O'Clock

Pipe Height: **8.4** (in.) Rod and Bar (Angled)
Pipe Material: **Clay** ☐ Pipe Lined
Invert Depth: **7.56** (ft.) Flow Characteristics: **Slow**
Deposits: ☒ None ☐ **Mud** ☐ Sludge ☐ Debris ☐ Grease
Silt Depth: **0** (in.) Deposits Extent:
Infiltration: **None** Pipe Seal Cond: **Sound**
